INVASIVE INSPECTION

STREET
Houston TX, 77xxx

Age of home: 18 years
Size: 5,228 sqft

Last rain: 1 day
Inspector: Eduardo Cardenas CER #NACHI19080522

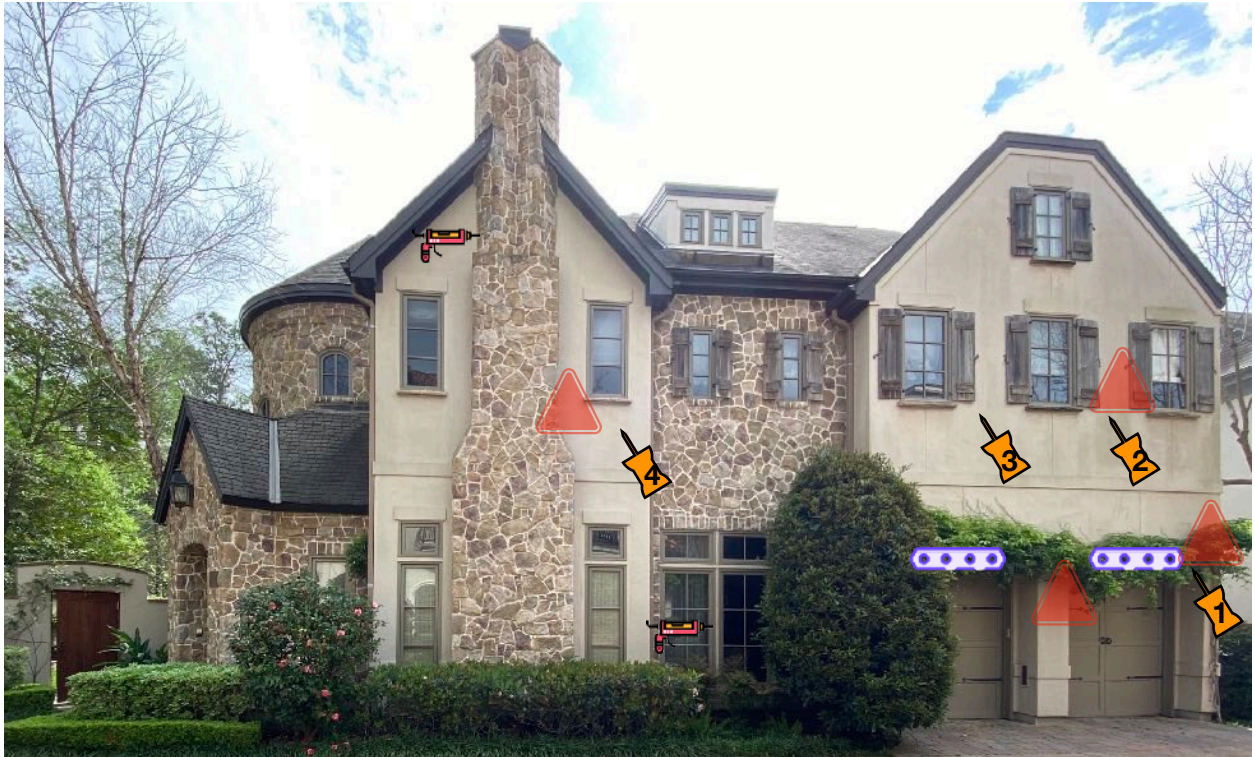
FRONT OF HOUSE

Moisture	17.7%	Firm	Elevated moisture and or compromise substrate noted at time of inspection.
2

Moisture	10.8%	Firm	Acceptable values of moisture
3

Moisture	11.2%	Firm	Acceptable values of moisture
4

Moisture	12.8%	Firm	Acceptable values of moisture

Caulk	Windows		Sealants at all window junctions have reached their life expectancy.

Caulk	Transition		The brick/stucco termination(joint) sealants are improperly applied.

Caulk	Penetration		The penetrations are not properly sealed(pipes, outlets, vents, anchors, rail systems etc)

Cracks	Present		Cracking & staining noted at garage door

Weep screed	Missing		House does not have a drainage relief at overhang (newer item not used at time of the houses original construction) no issues when probed and No repairs needed at this time

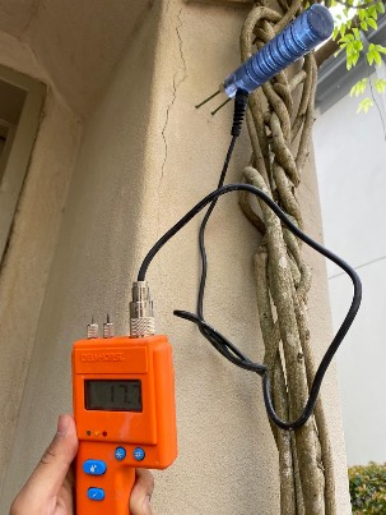
<p>Elevated moisture and or compromise substrate</p>	<p>Cracks present in garage section</p>	<p>No weep screed installed(drainage system)</p>

High moisture readings were observed in the substrate behind the stucco at some areas, however at this point the substrate/sheathing was found to still in a firm condition. It is recommended that all areas above or around these areas be sealed by a qualified stucco waterproofing contractor to prevent moisture penetration and to have the stucco rechecked three months after sealing these areas.

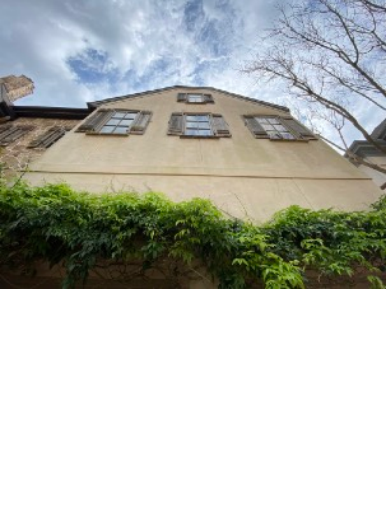
<p>Stains in front of the house</p>	<p>Sealants at all window junctions have reached their life expectancy.</p>	<p>Sealants at all window junctions have reached their life expectancy.</p>

There was heavily stained areas at the rear of the house. Recommend cleaning repainting as needed.

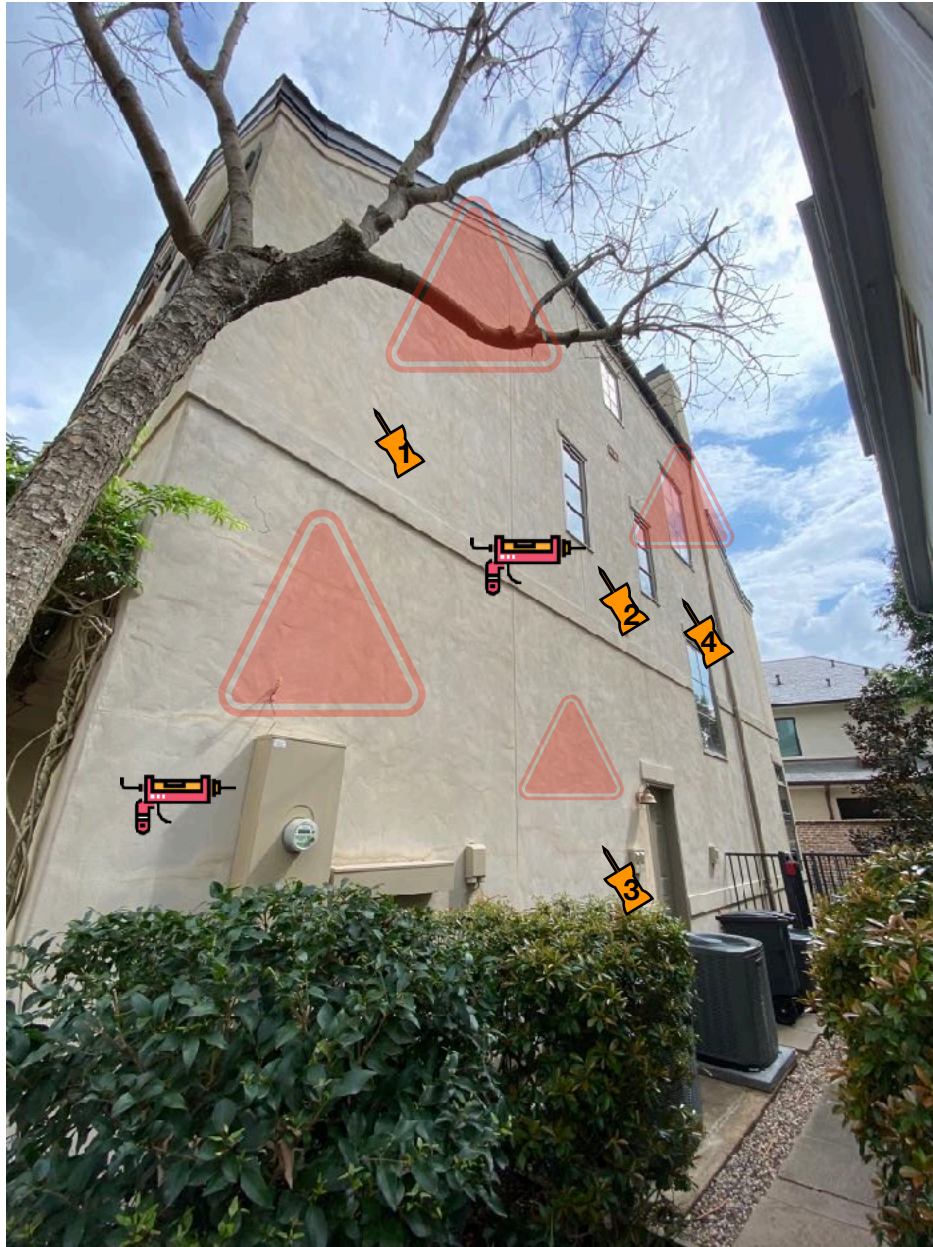
SOUTH SIDE

Moisture	12.1%	Firm	Acceptable values of moisture
2

Moisture	14.2%	Firm	Acceptable values of moisture
3

Moisture	10.8%	Firm	Acceptable values of moisture
4

Moisture	11.2%	Firm	Acceptable values of moisture

Caulk	Windows		Sealants at all window junctions have reached their life expectancy.

Cauk	Penetration		The penetrations are not properly sealed(pipes, outlets, vents, anchors, rail systems etc)

Cracks	Stucco		Cracking & staining noted in almost all south side wall

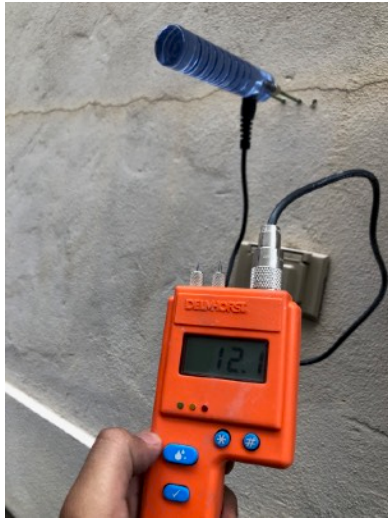
Low moisture values

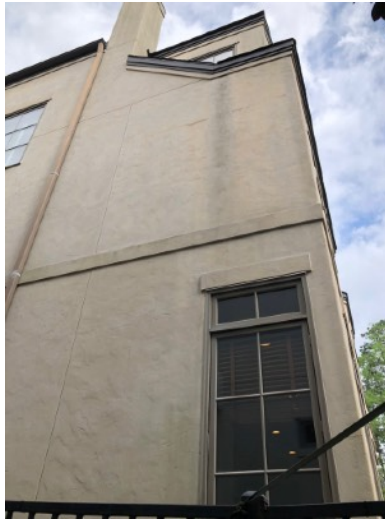
Cracks and stains

It is recommend to seal all cracks throughout house. The exact reason for the crack(s) was not determined at time of inspection. Some typical reasons for cracking of stucco material are known to be improper installation procedures at the time of application and/or settlement in the structure of the house. The inspector recommends that you consult a qualified stucco waterproofing contractor to seal/repair these areas.

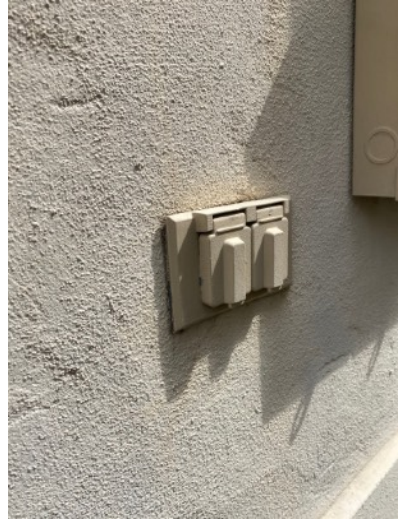
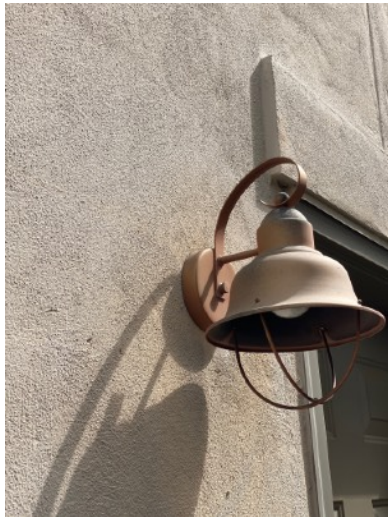
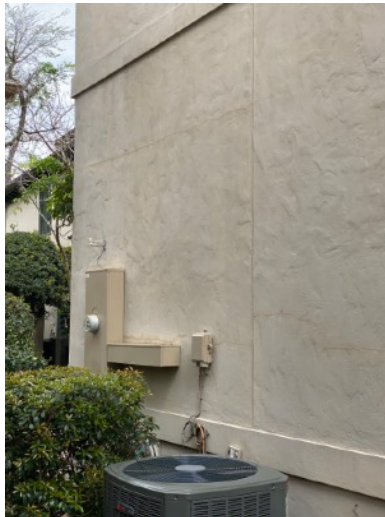
Penetrations not sealed

Many details and/or opening on this house lack adequate sealant. Windows, doors and penetrations through the exterior veneer system should be professionally sealed around the perimeters using a high quality, professional sealant (i.e., polyurethane). The sealant should be properly tooled into the joints to help prevent moisture intrusion and sealant separation. Stuko Inspections recommends that you consult with a stucco waterproofing contractor to seal all doors, windows, and penetrations as needed to avoid moisture penetration.

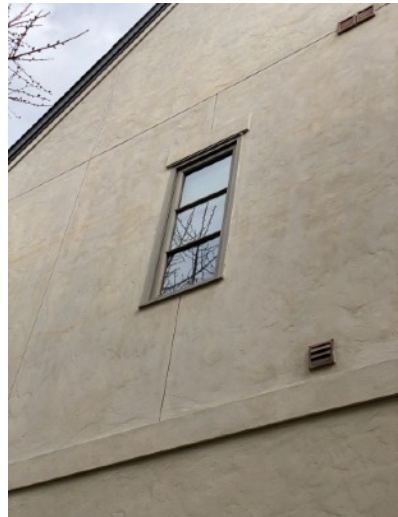
Vent not sealed properly

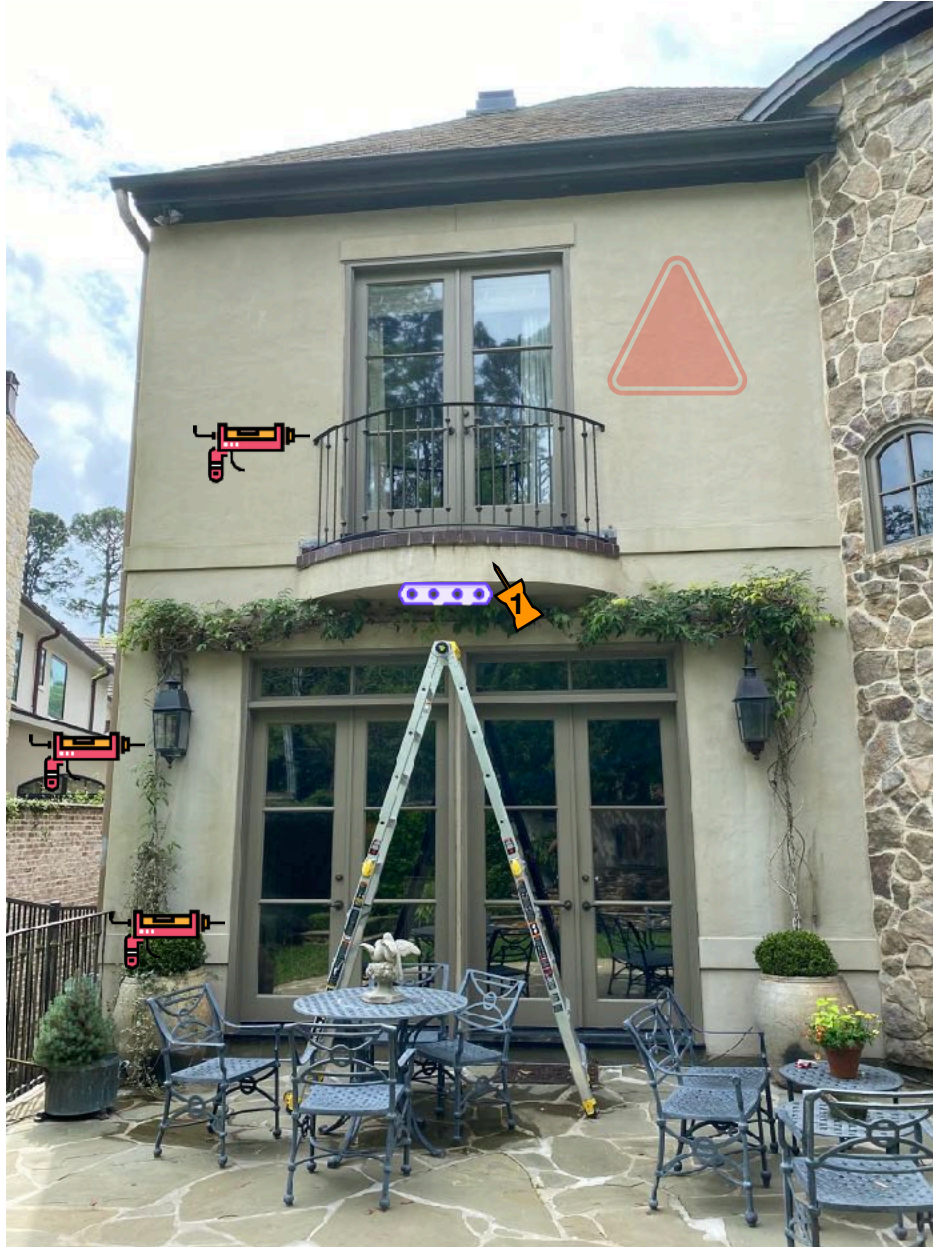
NORTH SIDE

Moisture	9.6%	Firm	Acceptable values of moisture

Caulk	Windows		Sealants at all window junctions have reached their life expectancy.

Cauk	Penetration		The penetrations are not properly sealed(pipes, outlets, vents, anchors, rail systems etc)

Cracks	Stucco		Cracking & staining noted

Weep screed	Missing		House does not have a drainage relief at overhang (newer item not used at time of the houses original construction) no issues when probed and No repairs needed at this time

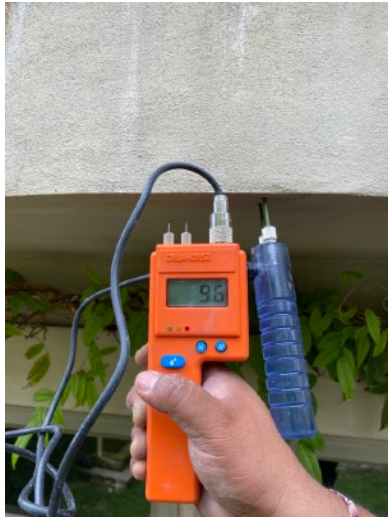
Low moisture values

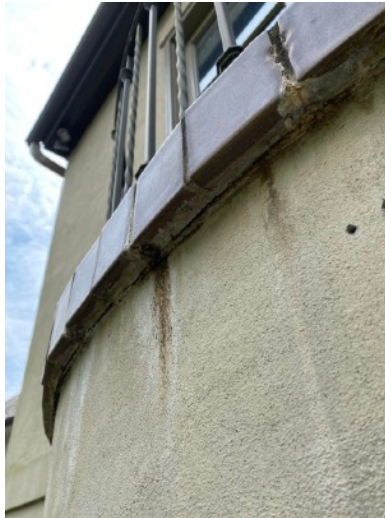
Missed drip edge flashing

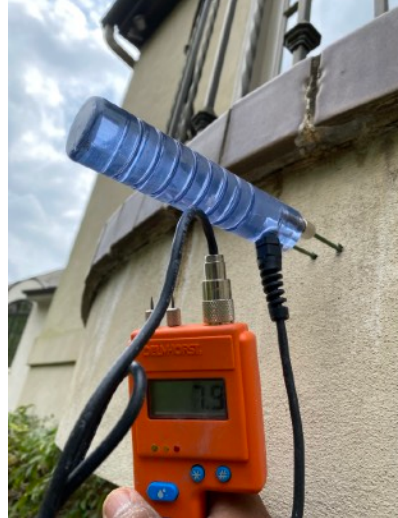
Low moisture

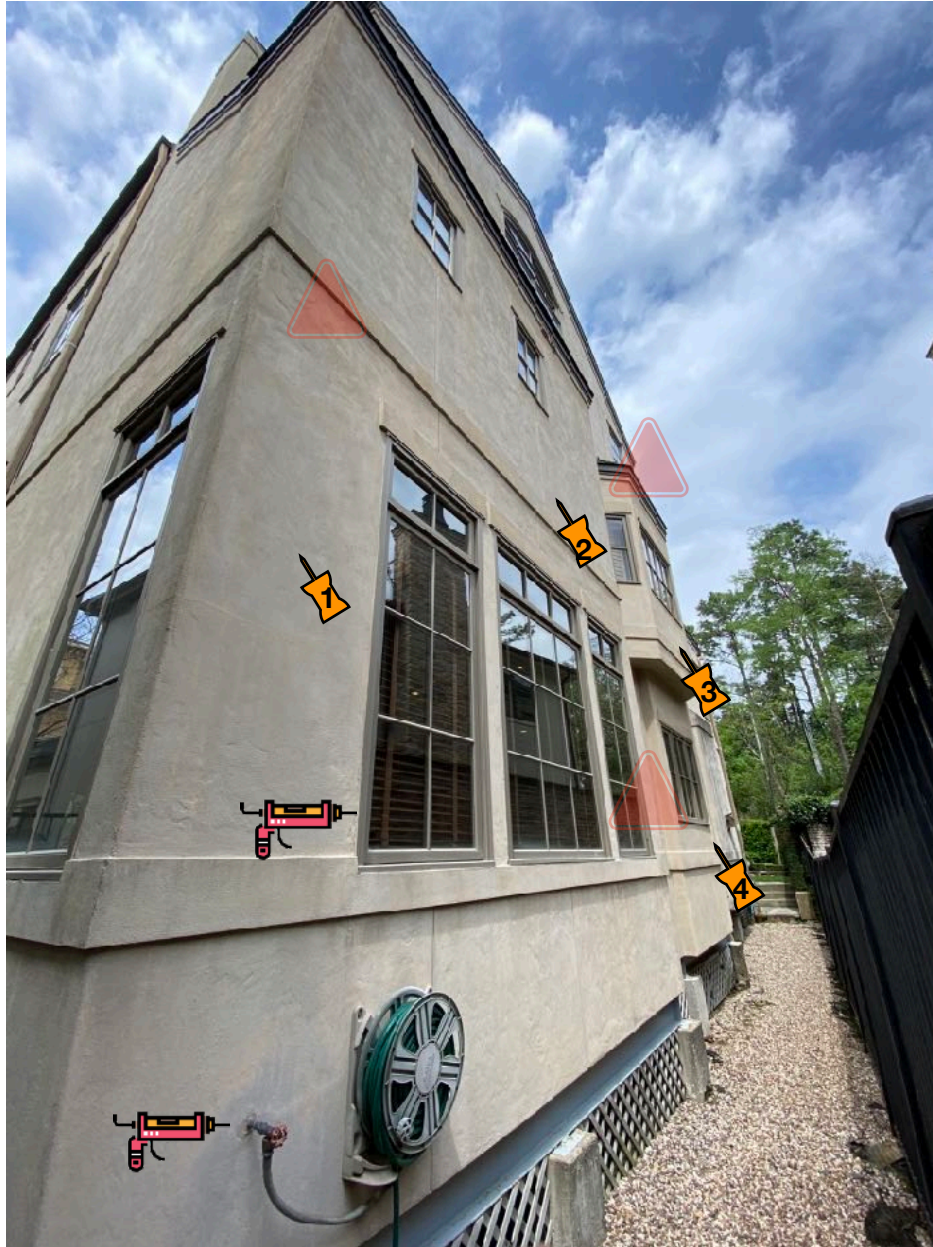
EAST SIDE

Moisture	7.5%	Firm	Acceptable values of moisture
2

Moisture	9.4%	Firm	Acceptable values of moisture
3

Moisture	13%	Firm	Acceptable values of moisture
4

Moisture	12%	Firm	Acceptable values of moisture

Caulk	Windows		Sealants at all window junctions have reached their life expectancy.

Cauk	Penetration		The penetrations are not properly sealed(pipes, outlets, vents, anchors, rail systems etc)

Cracks	Stucco		Cracking & staining noted

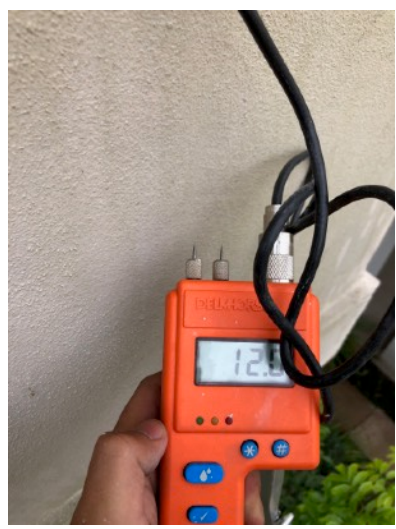
<p>Low moisture values</p>	<p>Cracks and stains</p>	<p>Penetrations not sealed</p>

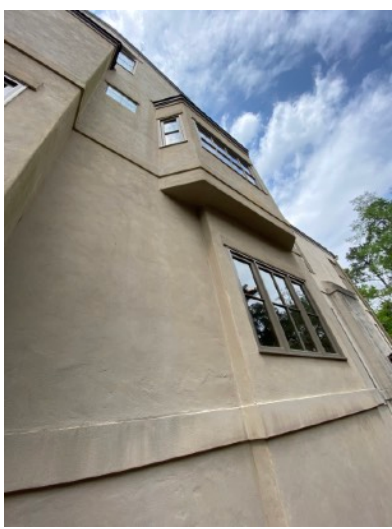
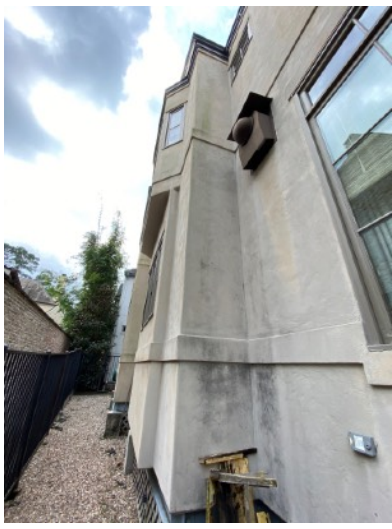
<p>Penetrations not sealed</p>	<p>Cracks and stains</p>	<p>Vent not sealed properly</p>

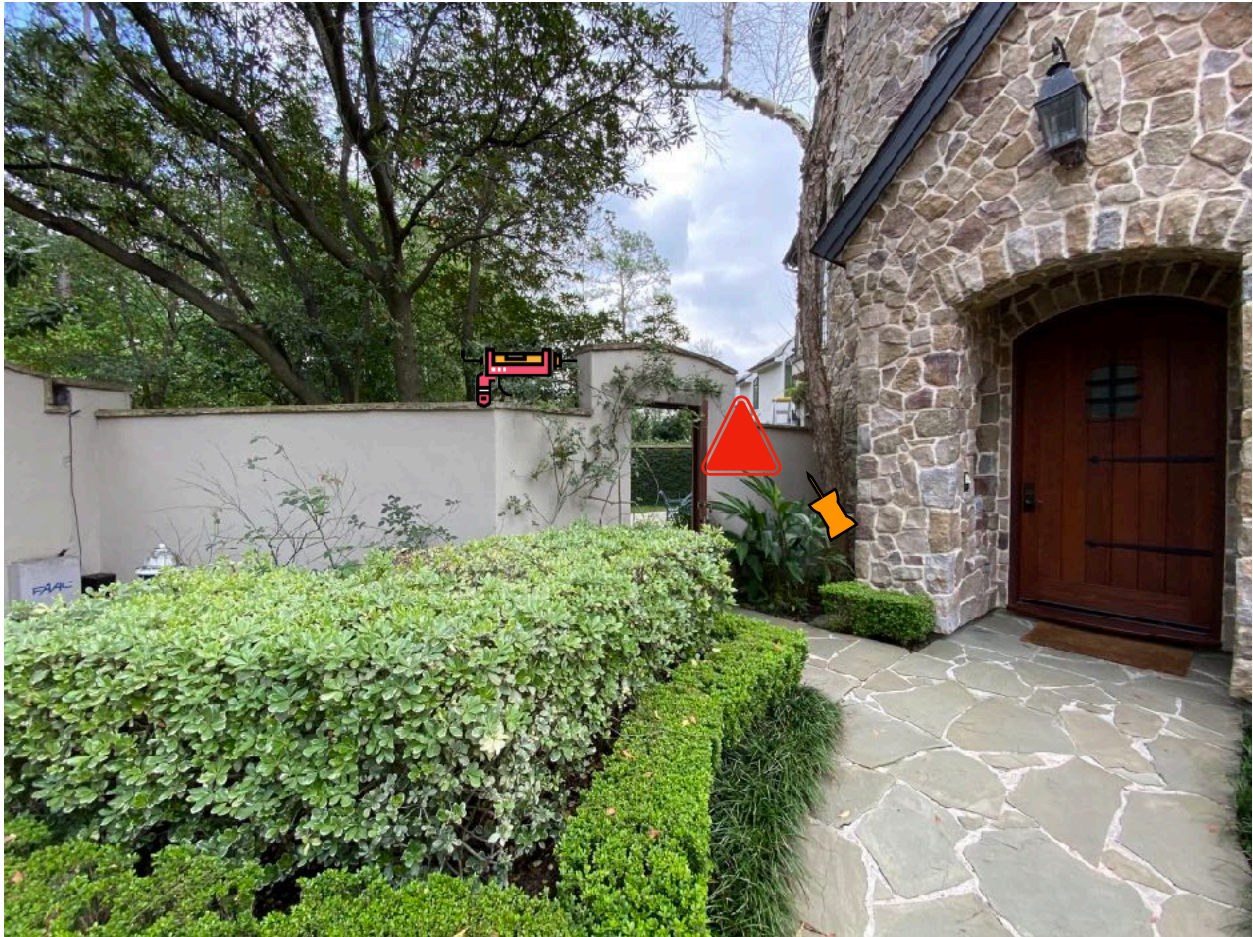
FENCE

Moisture	17.5%	Firm	Elevated moisture and or compromise substrate noted at time of inspection.

Caulk	Windows		Sealants not found

Cracks	Stucco		Structural issues

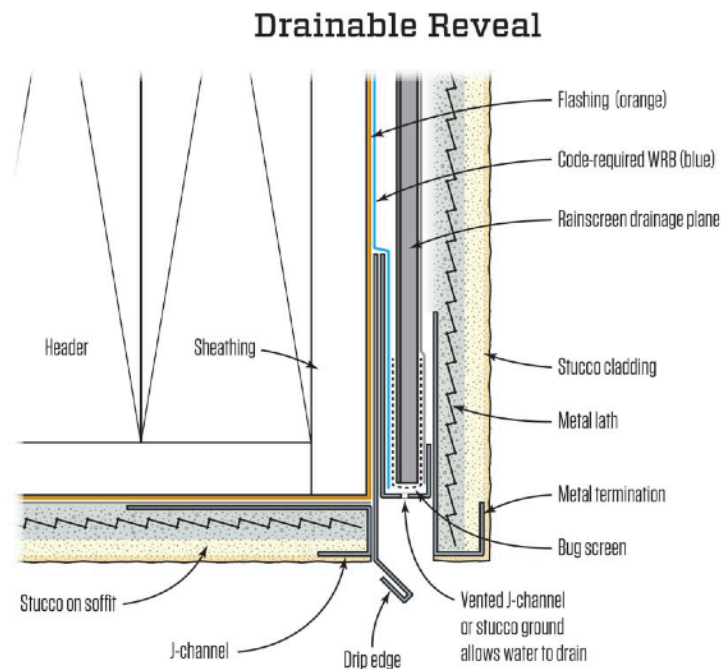
The stucco veneer on the front overhanging wall did not have a provision for a drainage plane to allow moisture a path to exit the stucco wall, as shown in the detail below, or a perforated bottom flashing detail to allow moisture to exit the stucco. It is noted that there were no adverse effects from not having this newer details when probed.
